SCOTT RIVER RIPARIAN WOODLAND REVEGETATION PROJECTS

Final Report FY 1996

*"Scott River Riparian Woodland Revegetation (French Reach)"
Project 96-JITW-05*

CalForest Nursery, Project Subcontractor

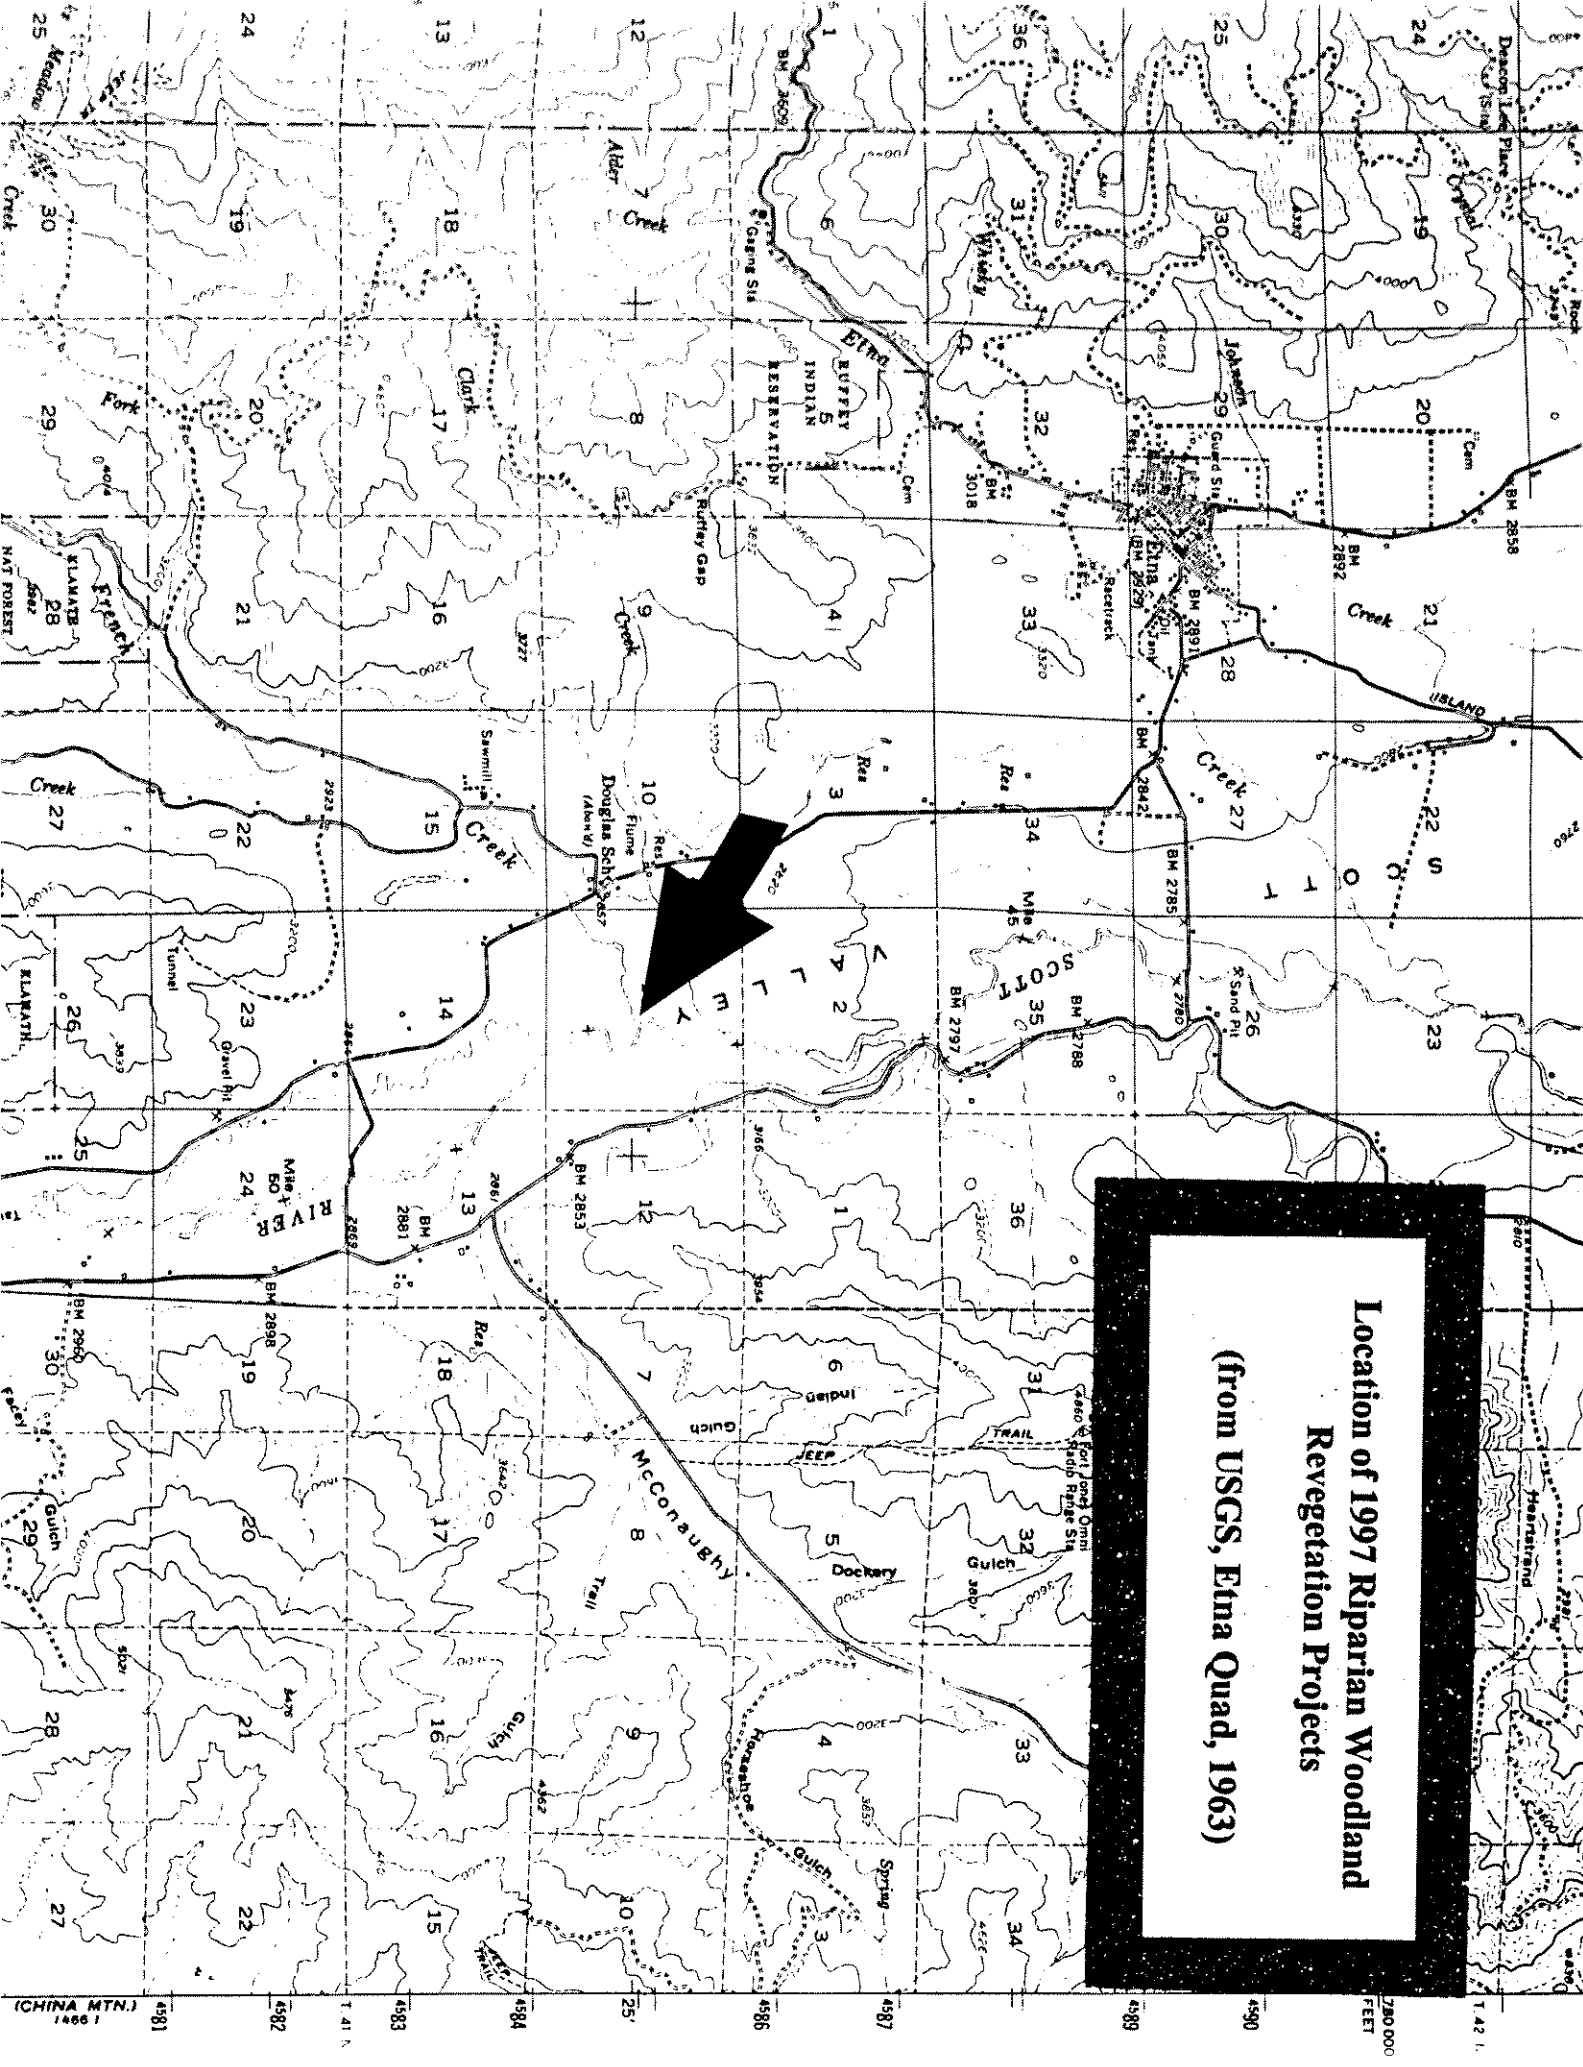
FIGURE 1.

**Location of 1997 Riparian Woodland
Revegetation Projects**
(from USGS, Etna Quad, 1963)

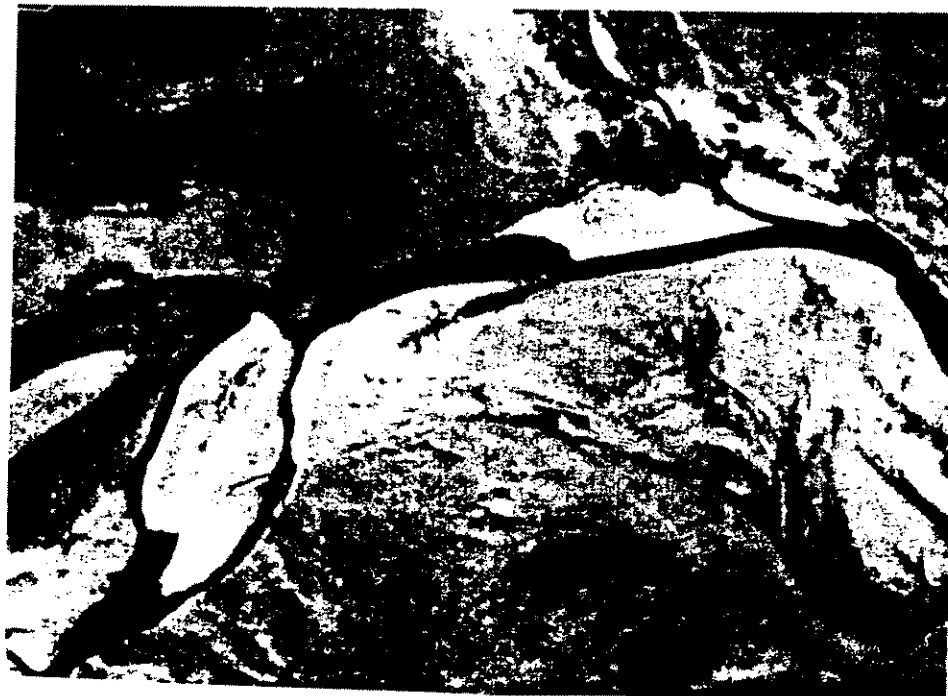
Photo taken by CalForest personnel April 1997 -
looking east from above French Creek.

1996 aerial photo courtesy of Siskiyou RCD

French Creek Bar after (above) and before (below) the New Years
Flood Jan. 1, 1997 - at the confluence with the Scott River.

The mouth of French Creek is located at T41N, R9W, Section 11 (USGS quad, McConaughy Gulch, CA.), with an elevation of 2800 ft (854m). The site has undergone extreme changes over the last year as the Scott River has shifted to the east approximately 400 feet (see attached photos). USGS flow records of the "New Years Flood" (Jan 1, 1997) include the forth largest flow on record with a peak discharge of 34,300 cubic feet per second (cfs) with a 14.4 year occurrence interval (Jay Power, USFS). For comparison, peak flows during early January 1998 were estimated at ~ 6,000 cfs and covered approximately 60% of the bars (estimates A.Eller, Cal Forest). The 1997 flood cut a new channel through the center of the existing 800 ft. (pre '97) bar and reconfigured the mouth of French Creek.

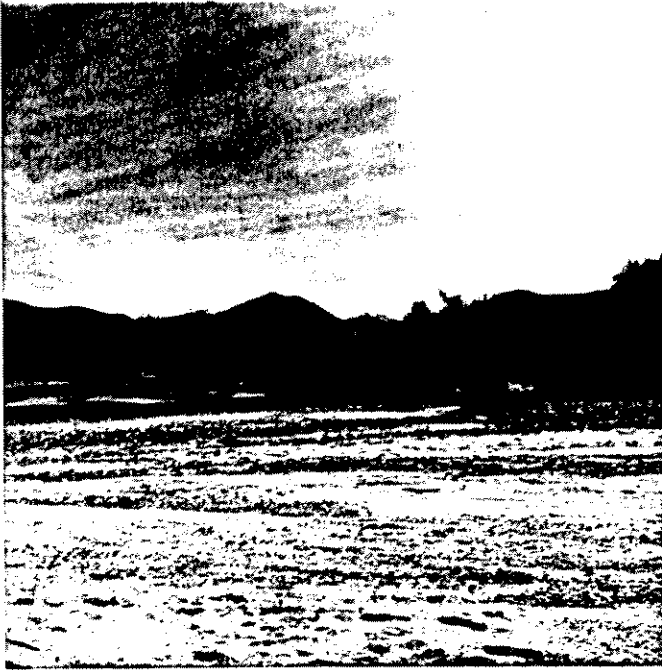
French Creek Bar - pre-planting 1997
DG sand at the mouth

Planting areas include portions of the "Center Bar" and "French Creek Bar" (see attached maps) The newly formed center bar is approximately 11 acres and is composed of unconsolidated cobble, gravel and sand. The only existing vegetation that remained was a 20' alder tree that was protected by a pine stump (~ 5' diameter), uncovered by the recent high flows. Siskiyou RCD (G.Black, pers.comm.) mentioned that several of these large stumps had been encountered throughout the area. The French Creek bar is approximately 4 acres and is entirely decomposed granitic (DG) sand. The sand is highly reflective, porous and heat conductive which provides a challenging planting environment.

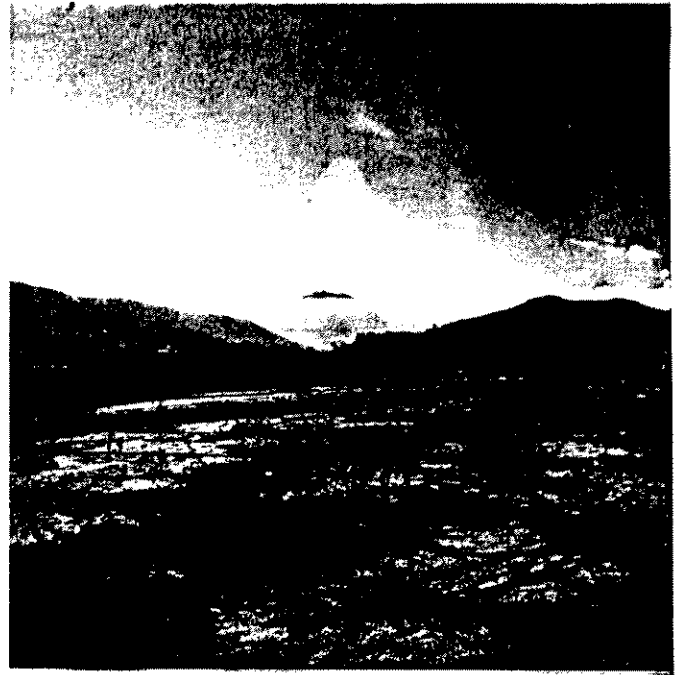
French Creek Bar - late summer 1997
sweet clover and pines visible
(picture taken farther away)

The area (site 6) with the lowest survival, the French Creek Bar (51%), suffered from logistical and site condition challenges. The late planting date of the French Creek Bar was the result of power supply problems to the main pump on the west side of Spencer's not being solved until mid - June. After power was restored and even with continuous watering, plants were negatively affected by reflected heat (e.g. willow plugs showed sunburn at the base). The watering schedule reflects a change from allowing a dry down period to continuous watering by the large increase in hours watered late in the summer. At this point heat damage had occurred yet watering was continued for those plants still alive. The site will be replanted in spring of 1998. Approximately 4 acres will be replanted with ~1,450 trees. Trees will be planted earlier (when flow conditions permit) and be mulched to increase soil moisture and reduce heat stress. The terrace (site 7) condition inventory was included with the bar.

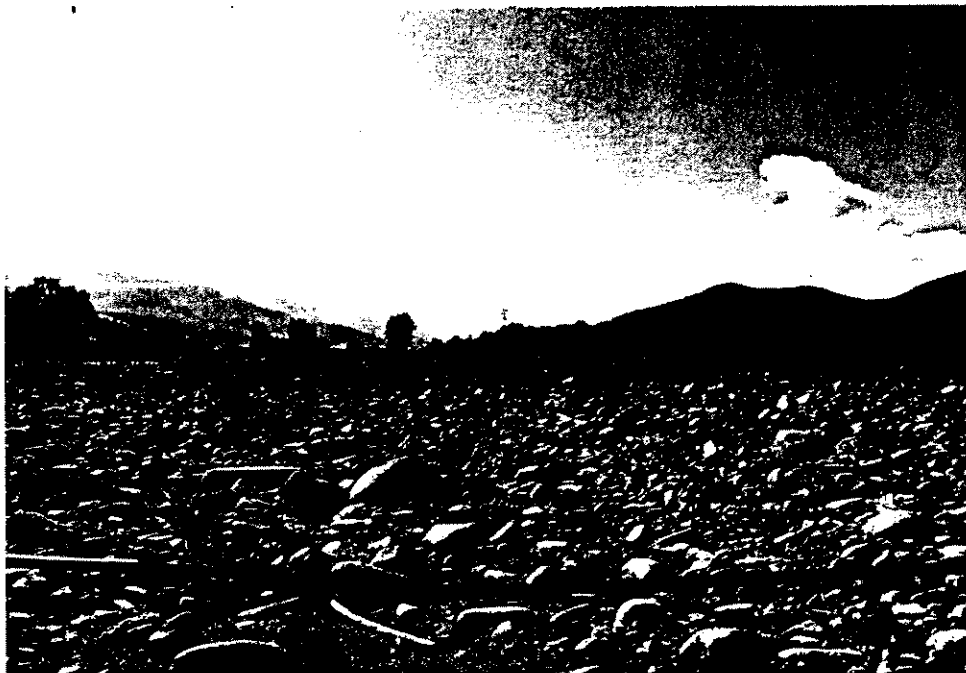
Center Bar of Spencers looking south
slow growing cottonwood in lower left

All pictures taken facing south with Mt. Bolivar in the background

In October 1997, tree survival and condition was evaluated using the sampling strategy discussed in the methods section. Planting dates, numbers of trees planted and tree survival are summarized in Table 1. Survival on the center bar was good (77%), but the growth of the plants was marginal. It took approximately 3 months to observe growth of the trees. After planting, the trees produced the first set of leaves, set bud and then remained at the original planting size for some time (A.Eller, pers.comm). The establishment time on gravel substrate is longer in comparison to growth seen on sites with soil substrate with the same planting time such as the east side of the Scott River.

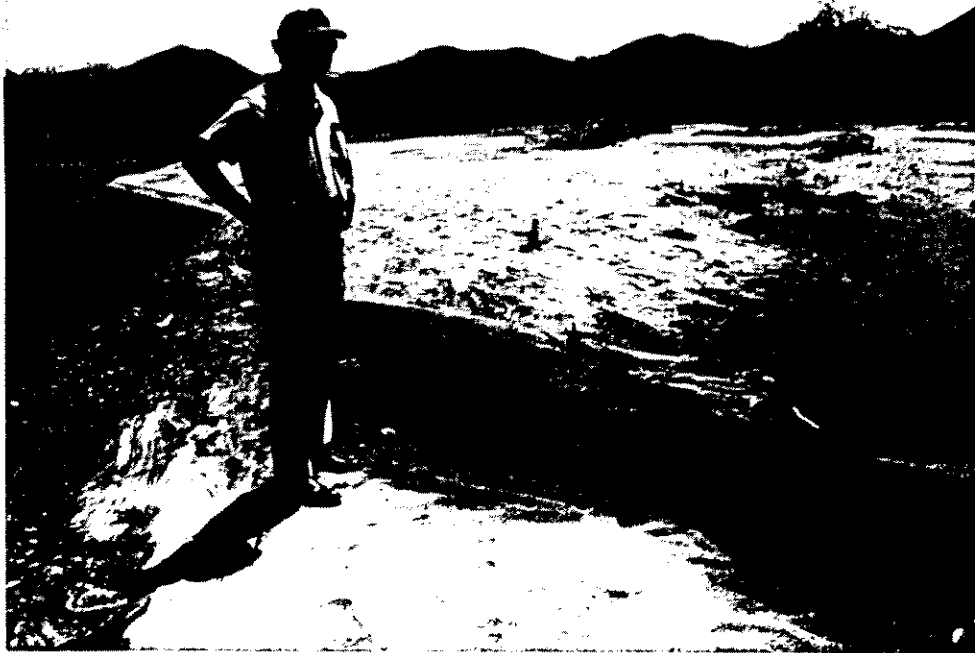
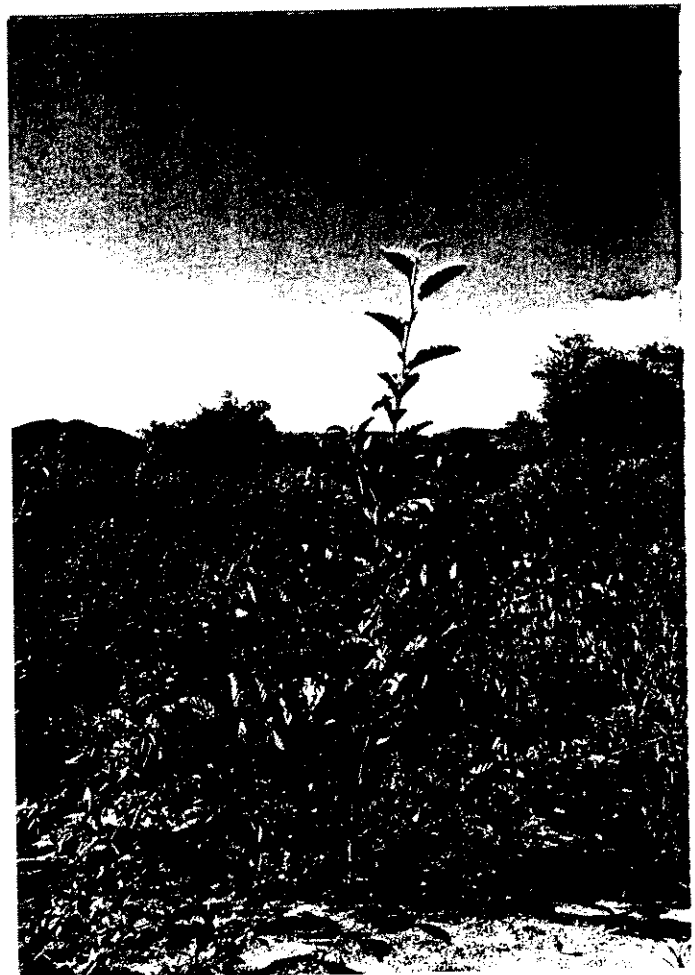
Opportunity plantings - plantings in wet sand (April 1997)

Opportunity Plantings
at the downstream end
French Creek Bar -
before and after

Use the notched hill in the
background as a reference

Growth on opportunity plantings after one year (C

The success of the "opportunity plantings" needs to be studied further. For example, some highlights include: alders planted in mid April on the downstream tip of the French Creek bar which grew to ~ 5 ft. and have withstood flows and deposition from 1998 winter flows (A.Eller, Cal Forest). The pines, in the same area also grew to 16". The plantings on the Center Bar free from irrigation, have survived (estimate A. Eller, Cal Forest). However, survival and condition percentages are unknown for the majority of trees planted. However, these plants proved irrigation is not necessary in some areas.
